Armstrong Chicken Farms Clean Water Act inspection (___ of 88 photos)
All photos taken by Kristine Karlson, EPA, on March 26, 2014.

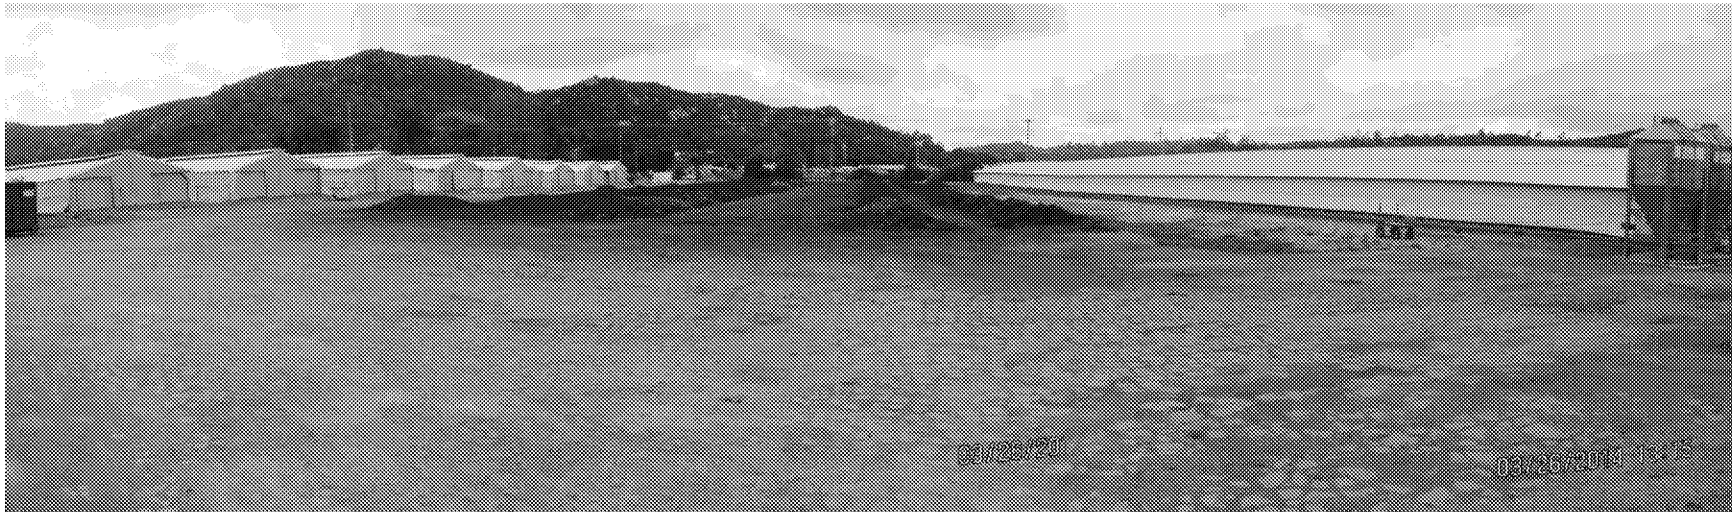
Photo 5 –Manure piles, located in the center of the facility. Manure is piled in rows to dry on a paved area. View is to the west. This image represents three photographs, stitched together.

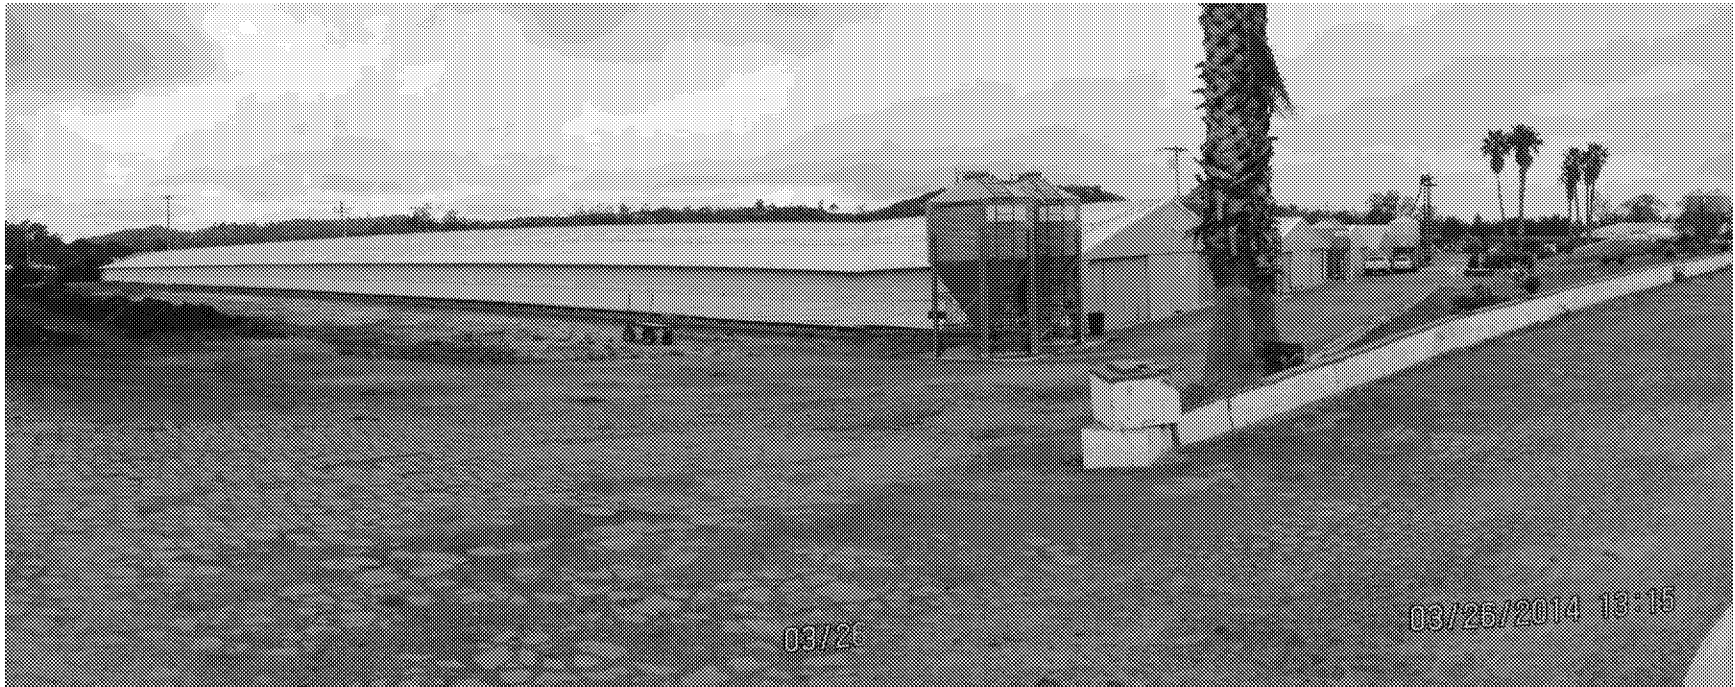
Photo 6 – View of hen houses to the north of the manure piles. View is to the northwest. There is an area between the manure piles and the hen house immediately to the north that is unpaved. This image represents two photographs stitched together.

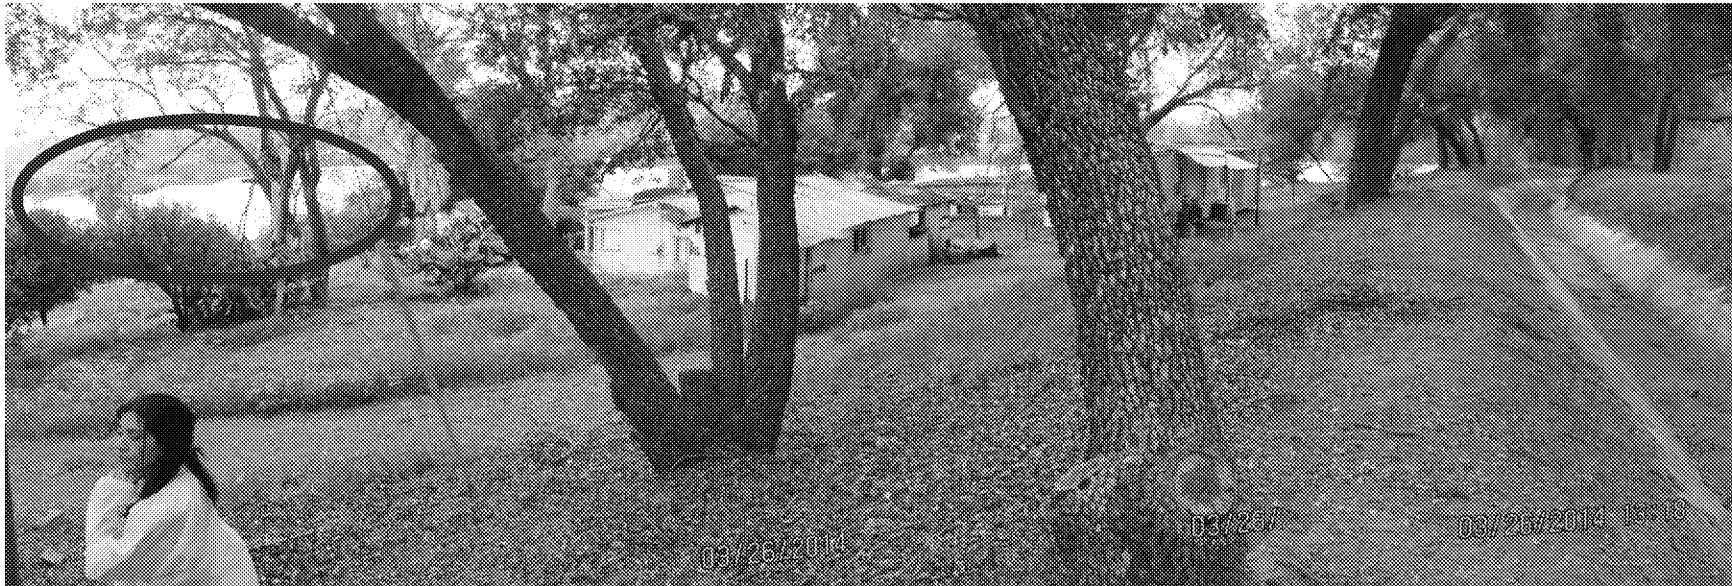
Photo 7 – View of canal running alongside and above the Armstrong Egg Farms facility. The canal is located uphill from the facility and does not appear to be able to receive flows from it. Circle marks hen houses downhill and to the west.

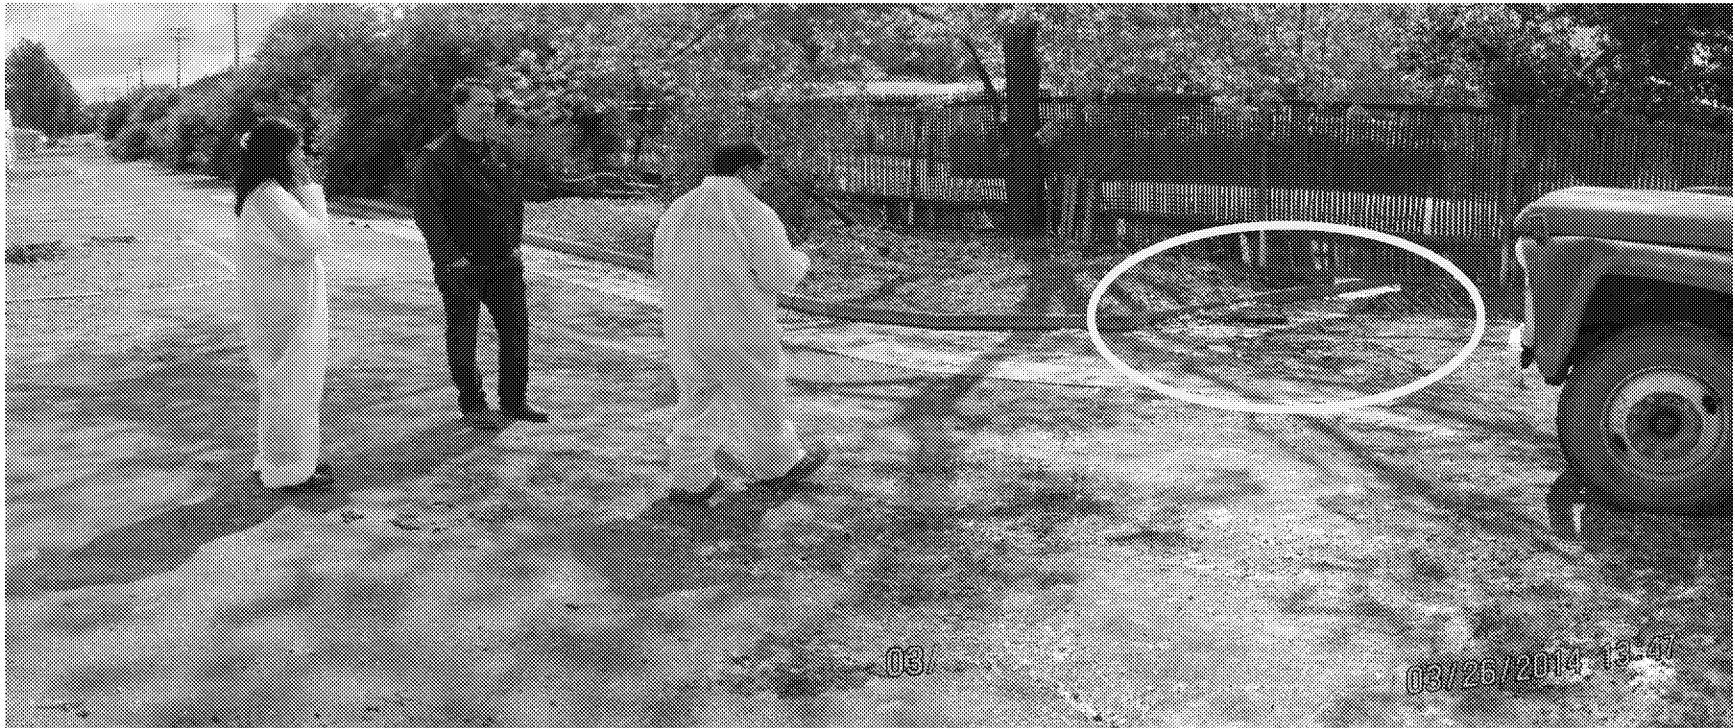
Photo 24 – Stitched photograph showing the curb along the western perimeter of the facility, leading to the main discharge point (circled). On the right is the red truck seen in Photos 22 and 23. This shows the relative distance between the conveyor belt and discharge point.
